**SUB:- STUDY REPORT ON HIGH SHAFT VIBRATION PROBLEM OF
TURBINE GENERATOR OF RIHAND UNIT#4 (500 MW)**

**STUDY REPORT ON HIGH SHAFT VIBRATION PROBLEM
OF TG#4 (500 MW)
AT
RIHAND STPS [6x500 MW]**

**RIHAND SUPER THERMAL POWER STATION
NTPC LIMITED, RIHAND, (UP)**

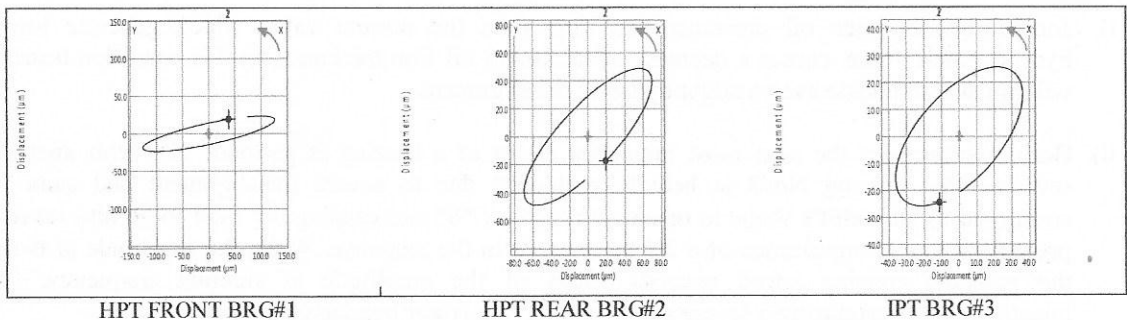
- v) Orbit analysis of HPT bearings indicates that vibrations are in forward precession whereas on IPT, it is under reverse precession which may be due to misalignment.

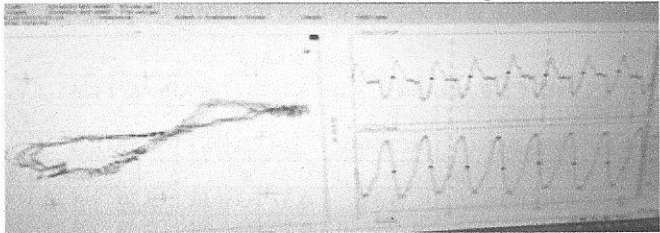
- vi) The Orbit plot taken during the load at 410 MW on 15th August 2019 indicated that Brg No 3 is highly preloaded, confirmed by orbit shape to resemble character "8" and causing the shaft to go into reverse precession due to appearance of a 2X component in the response.

Figure No 1 indicating higher amount of preload on the rotor which causes the orbit to become more elliptical and distorted. This is where the spring constant is much higher in the opposite direction to the pre-load than in the perpendicular direction to the preload. This produces the classical twice per rev frequency associated with alignment.

BRG No #3 Direct Orbit (Banana shape)

- i) Inspect all the Bearings of HP, IP, LP, Gen front for any abnormality. Check all the bearings for self - alignment & its seating and maintain proper clearances.
- ii) HP turbine has to be inspected/ replaced with the available module. Check swing value, which is an indication of high eccentricity, reduce to as minimum as possible.
- iii) Check HP & IP coupling alignment
- iv) As IP rotor is highly preloaded/misalignment, check IP rotor internals for any partial rubbing or contact,
- v) The coupling alignment of all rotors should be checked after removal of high points on the couplings faces.
- vi) Carryout roll checks of HP & IP for centering.
- vii) Check the catenary as per protocols.
- viii) LP-Gen Coupling faces have to be blue matched.

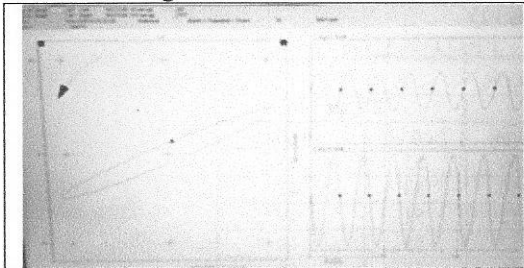
Figure No 2 (a)

- vii) A bearing preload due to cocked assembly can also cause orbit to have lower amplitude in one axis that makes the ellipse look thinner as shown in Figure 2(a). But heavy preloading due to misalignment can cause the shaft to go into sometime reverse precession; can be seen in Figure No 2(b). The forward precession is normal; reverse is not can be seen in full spectrum taken during load on 15th August 2019.

Brg No#3 1x Orbit

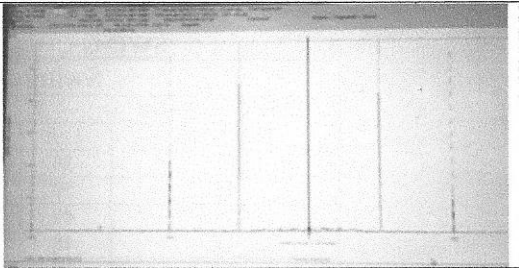
Figure No 2 (b)

Reverse Precession
