## SUB: STUDY OF HIGH SHAFT VIBRATION PROBLEM OF TG#6 [500 MW]

## PRELIMINARY REPORT ON ANPARA TPS TG#6

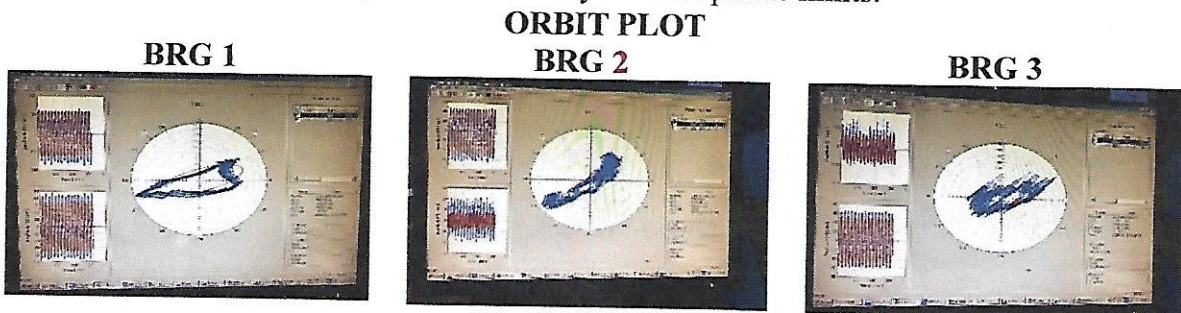
- a) **Orbit Plots:** The orbit recorded at bearings 1, 2, and 3 shows that bearing no. 2 is heavily preloaded, with a clear, elongated, banana-shaped trajectory and a dense, concentrated trace, indicating severe mechanical preload or shaft misalignment. The flattened orbit indicates that the shaft is heavily constrained in one radial direction, preventing it from forming a normal circular or elliptical orbit.

**Secondary Indicators:** The loop crossover (often appearing like a figure-8 or a loop-within-a-loop) in the orbit pattern indicates the presence of strong non-linear forces, typically caused by extreme reaction forces that push the shaft beyond acceptable limits.

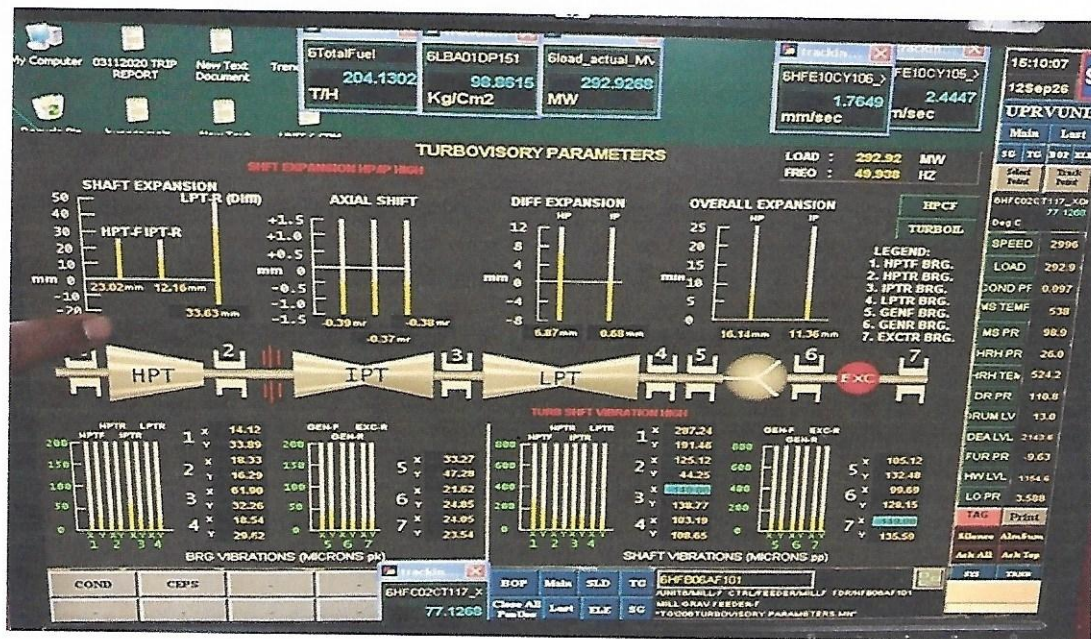
- b) **Correlate Thermal Expansion:** At a partial load of 299 MW out of 500 MW, the unit exhibits uneven casing expansion, with an absolute differential expansion (DE) of 6.87 mm, which exceeds critical thresholds for a 500 MW turbogenerator. Normal operating limits for differential expansion in large utility turbines generally range from  $\pm 3.0$  mm to  $\pm 5.0$  mm, depending on OEM (Original Equipment Manufacturer) specifications. Values exceeding 6.0 mm trigger an automatic trip zone.

**Casing Expansion & Pipe Stress Survey:** Inspections should include HPT sliding keys and guide slots to confirm that the turbine casing expands freely as it heats. Additionally, examine main steam piping supports and hangers, as frozen hangers can adversely affect turbine casing alignment and lead to the directional preloading seen at **Bearing No. 2**.

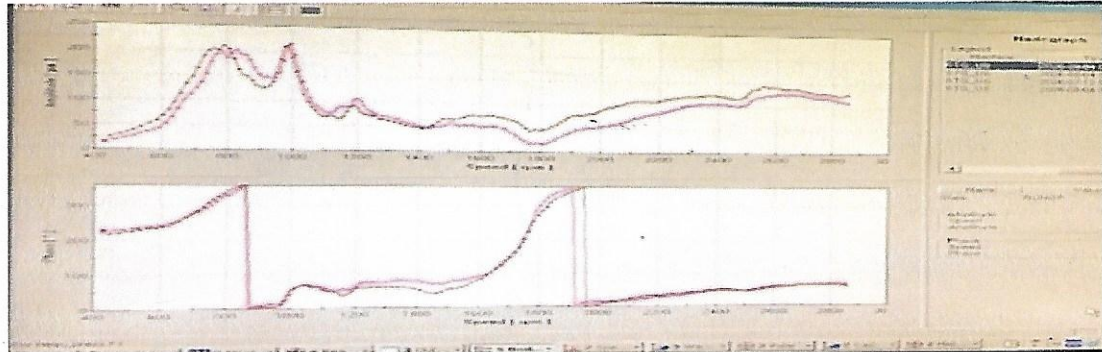
The historical Bode plot suggests that BRG No. 1 & 2 are operating within normal parameters; however, a critical speed shift is noted for (IPT) BRG No. 3, from 895 to 827, likely due to split resonance caused by bearing asymmetry. The critical speed shift is accompanied by an amplitude dip and is caused by split resonance.

This 14.62% reduction represents an enormous structural shift for a massive 500 MW machine. Standard residual unbalance cannot cause this, indicating a substantial loss of the system's geometric constraints or load-bearing capability at Bearing No. 3.

Potential issues may stem from structural degradation beneath the pedestal, including cracked or deteriorated epoxy/cementitious grout, loose or broken foundation anchor bolts, or damage to the bearing housing support structure/pedestal seat.
