# **Vibration Signature Analysis-A Case Study On "Oil Whirl" Problem In Turbine Bearings**

C G Porwal,

Monitoring & Diagnostics Center  
National Thermal Power Corporation Limited

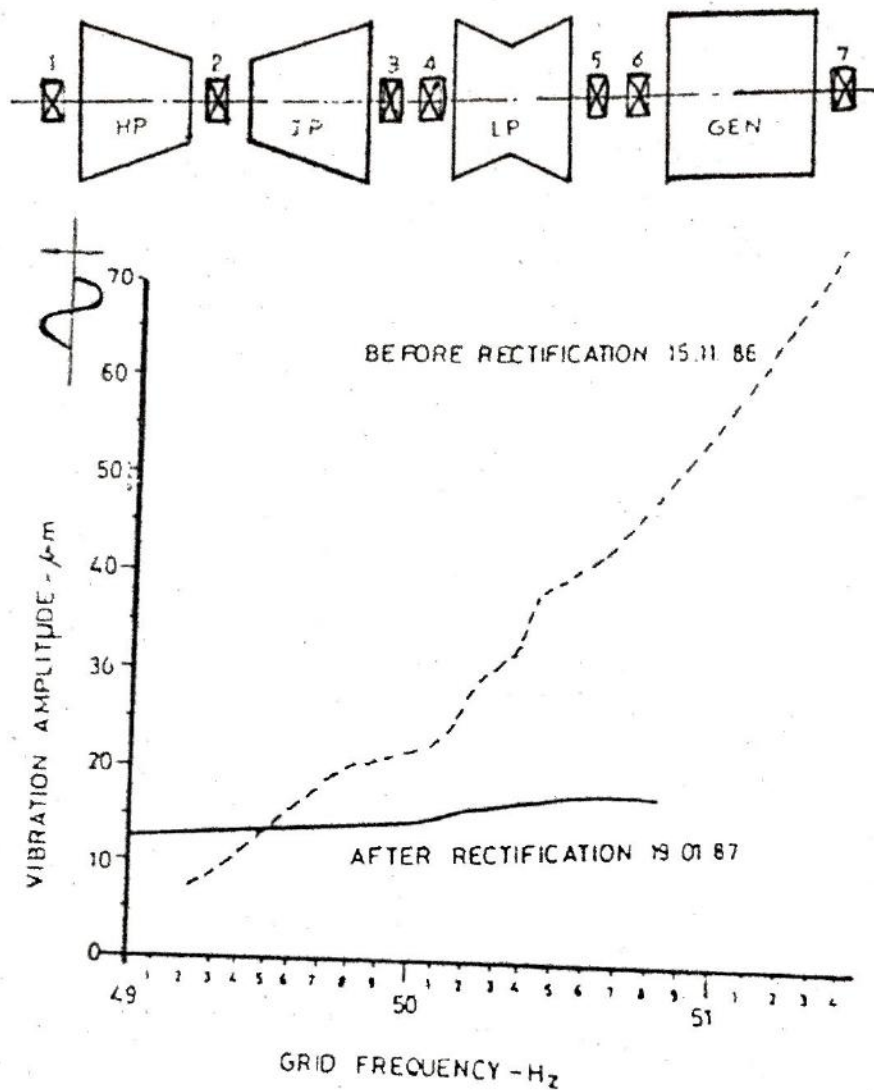
Fig no. 1

no abnormality was noticed. Bearing top and side oil clearances were within the limits. Hammer test did not reveal of any loose contact of babbitt. The unit was re-synchronized and further measurements were recorded on all the bearings of turbine at various loads and speeds. Vibration of bearing no 3 was fluctuating with frequency.

The amplitude of vibration had an increasing tendency with grid frequency irrespective of load, as brought out in Fig No1.

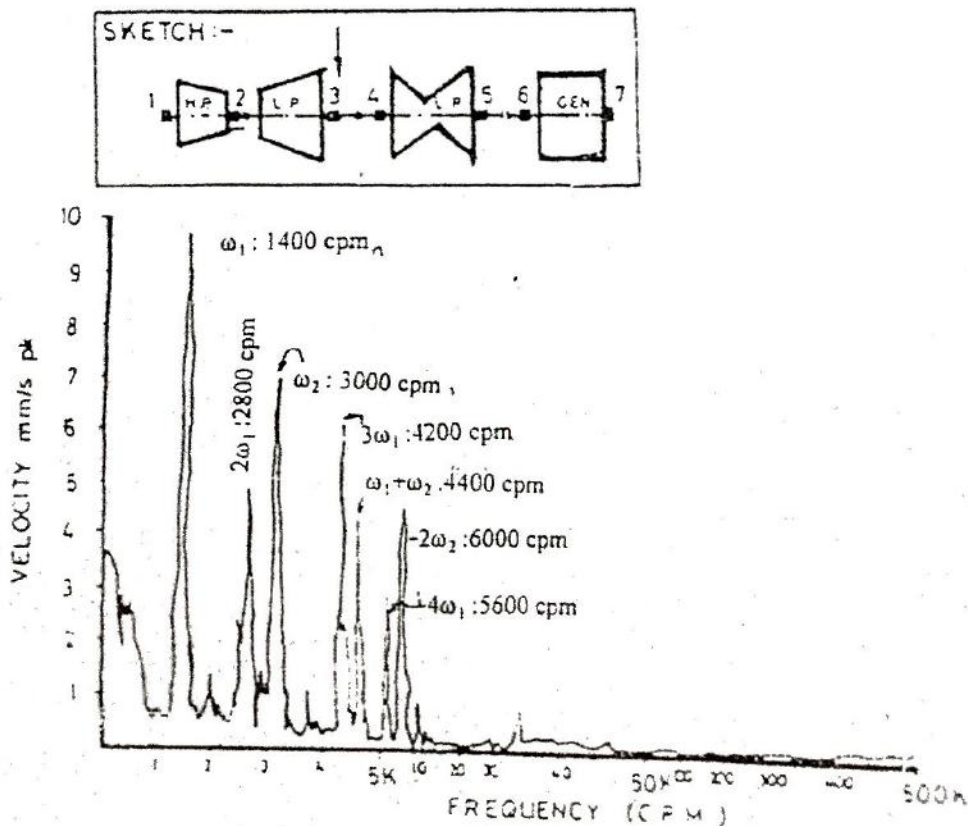
Fig. No 2

Vibration at discrete frequencies (Fig No 2) are analyzed as follows:

- 1400 cpm:** Vibrations at this frequency is maximum in vertical direction and occurs at 45.2% of rotational speed (3000 rpm). It has been established that vibration occurring at 42- 48% of speed will be due to oil whirl: Oil whirl phenomena is described later.

- 2800 cpm:** This is the 2nd harmonic  $2 \times$  rpm of 1400 cpm of the fundamental. Elimination of 1400 cpm vibration will automatically eliminate this.

- 3000 cpm:** This is the vibration produced at the rotational speed of the turbine speed.
- 4200 cpm:** This is the 3rd third order harmonic ( $3 \times 1400$ cpm).

- 4400 cpm:** This is the modulated signal with 1400 cpm and 3000 cpm vibration and will automatically vanish when 1400 cpm is eliminated.
- 5600 cpm:** This is the 4th order harmonic vibration produced by ( $4 \times 1400$  cpm).

- 6000 cpm:** This is the 2nd order harmonic ( $2 \times 3000$  cpm) of vibration produced by the rotational frequency.

From the above analysis of discrete frequencies, it will be seen that the culprit is the 1400 cpm vibration component due to oil whirl.

- a) Bearing no 3 to be inspected for the following
  - Healthiness of its white metal
  - Oil clearances (side and top Oil clearances)
  - Tightening of parting plane bolts
  - Matching of support pads housing
  - Contact area of journal with the bearing
- b) Bearing no 4 should also be checked for oil clearances and journal contact area

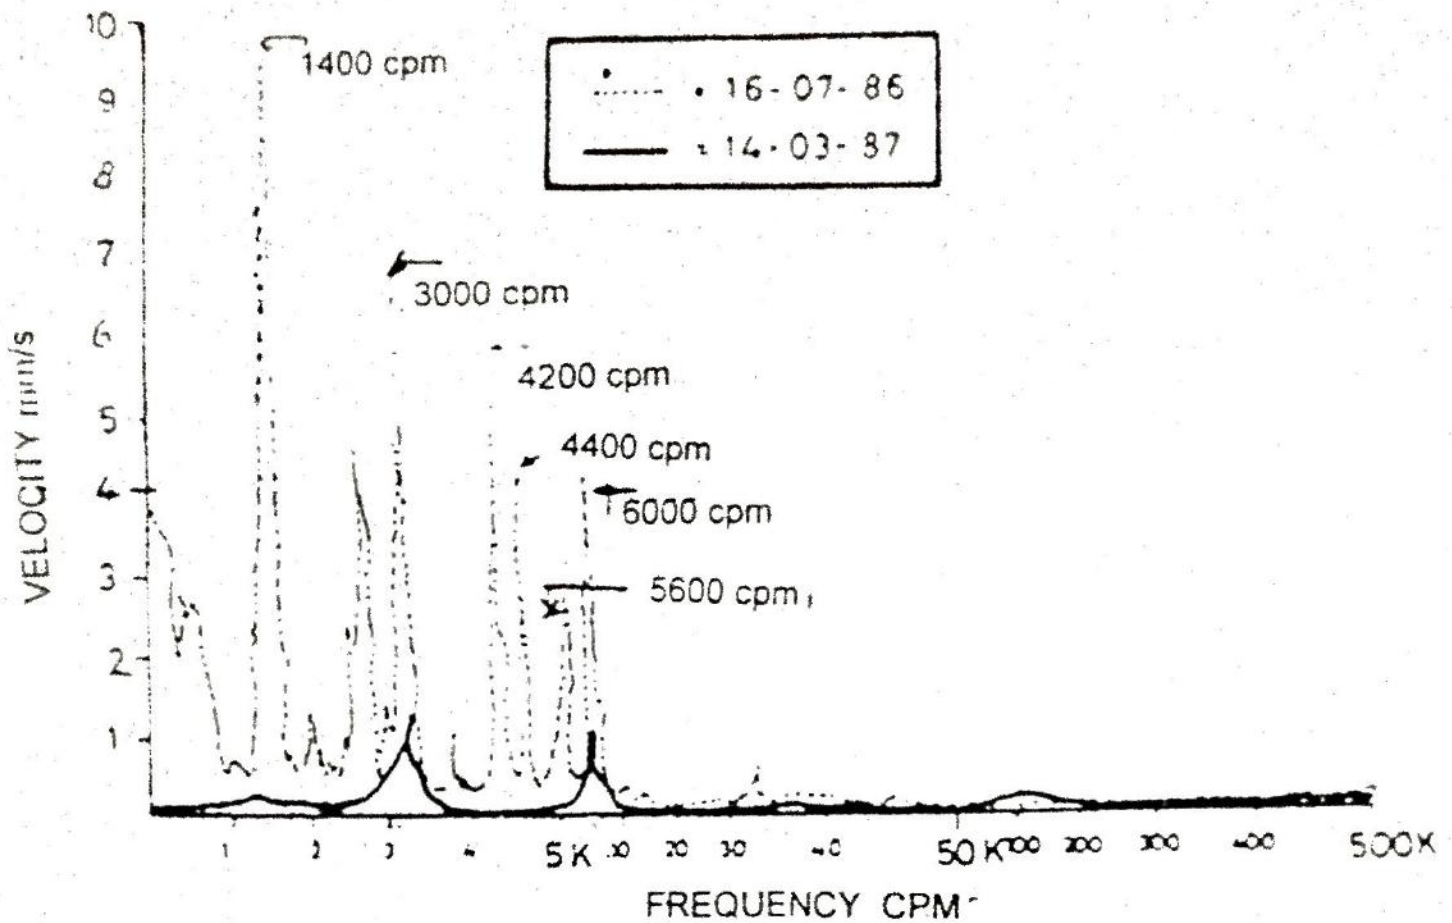
Figure No. 3

The unit after rectification of bearings no 3 and bearing No. 4 was brought back the vibration measurements were recorded on bearing no 3 and the results were encouraging. The vibration at different grid frequencies indicated that maximum level of vibration now at 50.8 Hz is only 16 microns pk-pk, which is acceptable for smooth operation of the turbine. Comparison of vibration data and spectrum before and after rectification is represented in Table 1 and Fig. No. 3.

- Bearing no 3 was raised by 0.15 mm by providing shims.
- Bearing no 4-bottom pad was scraped and matched for 90 % contact area.
- The healthiness of white metal of both the bearing No 3 and 4 were checked and found in good condition
